# Experimental and analytical investigation of dynamic crack patterns in automotive windshield sheets subjected to low velocity impact

Automotive Fluids and Structures Analysis Research Laboratory, School of Automotive Engineering, Iran University of Science and Technology, Tehran 16846-13114, Iran

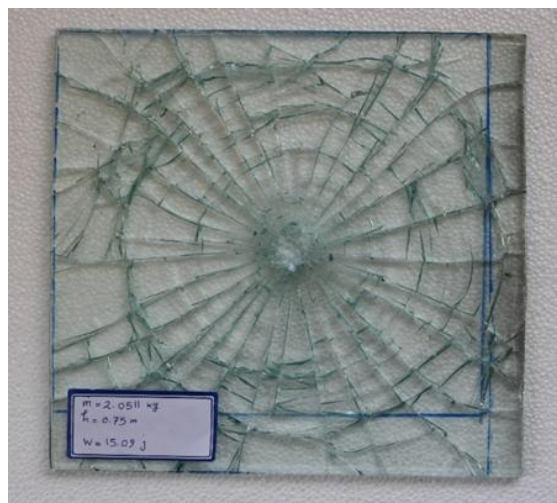
**Fig12.** .specimen after test code D-B-T-5

Laminated glass specimen after test code D-B-T-5 is shown in Fig.12.

As it is observed from Fig.12, the impact region at the center of specimen (powdering region) is a circle with approximate diameter of 20mm in which cracks density and consequently damage level is higher than the other regions of specimen. The projectile has penetrated to the depth of 4mm of the laminated glass, indeed the upper layer glass has fractured and PVB interlayer has elongated, but no tearing is observed. At the center of test code D-B-T-5 laminated glass, penetration depth has increased in comparison to test codes D-B-T-4 and D-B-T-3. Total number of circumferential cracks of the specimen is 5 which are placed at 47, 70, 80, 90 and 105mm distance from the center. At the vicinity of borders (close to clamping spots), net shaped diagonal cracks are more congested. Cracks have been propagated from the impact surface of laminated glass. At all 4 sides of the specimen, diagonal asymmetrical net shaped cracks have been made. At both upper and lower glass layers, radial cracks converge at the center of the specimen and their divergence increases at larger radiuses. Most of radial cracks have reached the borders of specimen and released their internal impact energy by this way.

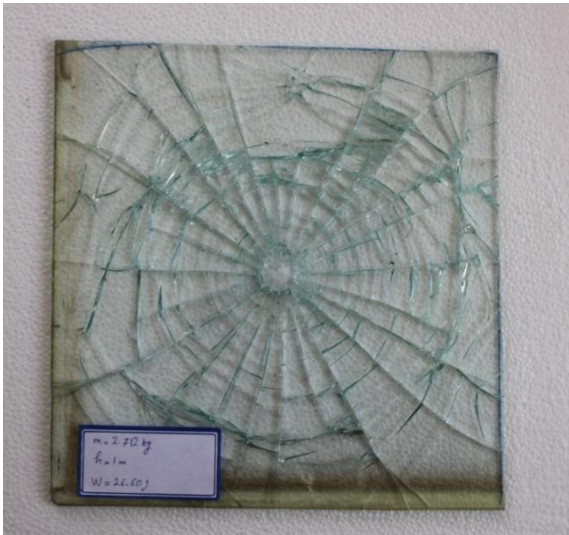
**Fig14.** .specimen after test code D-B-T-6

Laminated glass specimen after test code D-B-T-6 is shown in Fig.14.

As it is observed from Fig.14, the impact region at the center of specimen (powdering region) is a circle with approximate diameter of 20mm in which cracks density and consequently damage level is higher than the other regions of

specimen. In this test, the projectile has penetrated thoroughly in specimen. Therefore the glass layers have fractured and the PVB interlayer has torn. This test (test code D-B-T-6) has higher impact energy level in comparison to test code D-B-T-5. It can be observed that the penetration at the center of test code D-B-T-6 specimen is deeper than test code D-B-T-5, on the other hand the number of radial cracks is smaller in test code D-B-T-6. In fact, the impact energy has been released mostly through penetration in thickness direction and residual energy has released through radial and circumferential cracks. The radial cracks in test code D-B-T-6 are nearly symmetrical and about 24 which has decreased about 20% in comparison to test code D-B-T-5, but the penetration depth has

increased about 50%. It shows that approximate 76% increase in impact energy level in test code D-B-T-6 in comparison to test code D-B-T-5, has been released mostly through increase in penetration depth and radial and circumferential cracks in further priorities.

There are 6 circumferential cracks in the specimen at the radiuses of 34,41,51,60, 70 and 95mm from the center of the laminated glass sample. It can be seen from Fig.14 that the radial cracks have been initiated from the impact surface of laminated glass and propagated along thickness direction. In one side of the laminated glass, sectors of circumferential cracks like grids, have connected radial cracks to each other. 12 out of total 24 radial cracks have extended to the borders of the specimen and released their internal impact energy by this way. The acceleration versus time graph of test code D-B-T-6 is illustrated in Fig.15
