# Experimental and analytical investigation of dynamic crack patterns in automotive windshield sheets subjected to low velocity impact

P. Shojaei Shahmirzadi, H. Saeidi Googarchin\*

Automotive Fluids and Structures Analysis Research Laboratory, School of Automotive Engineering, Iran University of Science and Technology, Tehran 16846-13114, Iran

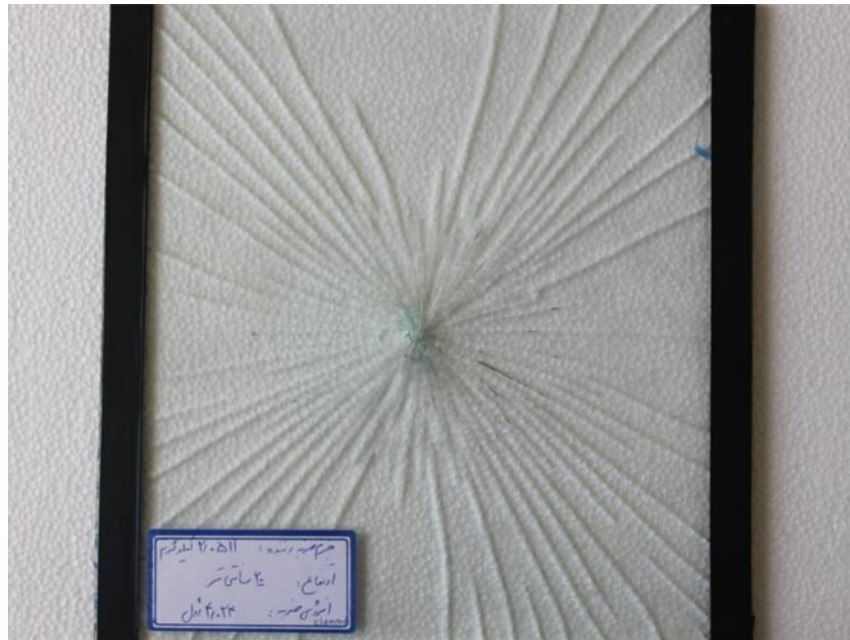
Fig4..specimen after test code D-B-T-1

Laminated glass specimen after test code D-B-T-1 is shown in Fig. 4.

As it is observed from Fig. 4, the impact region at the center of specimen is a circle with approximate diameter of 3 mm. Indeed, due to low energy of impact, the impactor has not caused remarkable damage at the impact area. In addition, the impactor has not penetrated in the specimen and damage is superficial. As a matter of fact, the impact energy has been released through radial cracks propagation and the impactor has not had any penetration in the specimen.

It can be inferred from Fig. 4 that the radial cracks in test code D-B-T-1 are nearly symmetrical and about 67 from which this quantity, 60 cracks have been extended to the borders of specimen and released their energy

through reaching the border of specimen. As a consequence, the damage mode is dynamic crack propagation. In this specimen, no circumferential crack is observed which can be due to low level of impact energy. Consequently, it seems that although all the impact procedure occurs in less than some milliseconds, radial cracks are made at the first stage. At the vicinity of impact region, some sectors of circles are observed which are distributed sporadically to the approximate radius of 6 mm from the center of specimen. Moreover it can be seen from Fig. 4 that the radial cracks have been propagated from the impact surface of laminated glass. On the other hand, the radial cracks in this specimen are superficial and have not reached the lower surface of specimen, hence it can be understood that the fracture of laminated glass begins with superficial cracks at the upper surface of specimen.
