## Study of the effect on manufacturing parameters on the fatigue behavior of aluminum engine mounting bracket

The engine mounting bracket connects the engine to the car body and plays a key role in reducing vibrations and supporting the engine's weight and dynamic loads. It must be designed to withstand cyclic forces during normal use but fail safely in high-impact situations, like accidents, to minimize damage. This study examines how manufacturing parameters affect the fatigue performance of aluminum engine mounting brackets in cars. According to the staircase-Locati fatigue test results, the relative mean resistance load was measured at 1.24 with a relative scatter of 0.07, placing it in the unsafe operating region for the engine mounting bracket. To address this, a finite element analysis was carried out to identify critical areas on the part and implement modifications to enhance its performance. The crack initiation and growth regions observed during the fatigue tests aligned closely with the critical zones identified in the finite element analysis. Following the modifications and the removal of production defects, a series of experimental tests were conducted to assess the

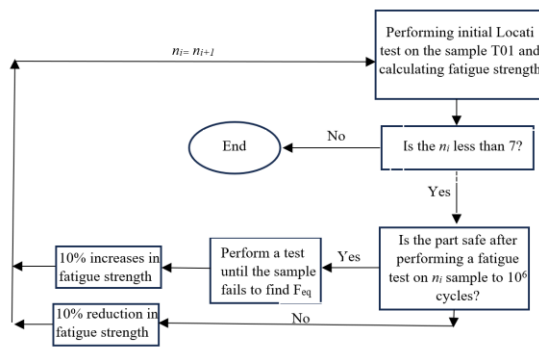
**Figure 2.** Flowchart of staircase and Locati test.

In the staircase test [23], the failure force obtained from the primary Locati test is applied to the piece up to  $N_{ref} = 10^6$  cycles. The possible state of the piece under test will be in two ways:

a) If the part remains healthy and without any defects until the end of the test, the secondary test of Locati is repeated on the part with an increase of 10% force up to  $10^6$  cycles and this process continues until the failure of the part; for the next

piece, the above steps are repeated with a 10% force increase up to  $10^6$  cycles.

b) If a crack or fracture is observed in the part during the test, the staircase test is stopped and the next part is tested with a 10% reduction in force and repeating the above process.

In Figure 2 the steps of staircase and Locati test presented.
